**DEPARTMENT OF TRANSPORTATION****DIVISION OF ENGINEERING SERVICES**

Contract #: 04-0120F4Cty: SF/ALA Rte: 80 PM: 13.2/13.9File #: 13.28**WELDING INSPECTION REPORT****Resident Engineer:**Pursell, Gary**Address:** 333 Burma Road**City:** Oakland, CA 94607**Report No:** WIR-012588**Date Inspected:** 09-Mar-2010**Project Name:** SAS Superstructure**OSM Arrival Time:** 1000**Prime Contractor:** American Bridge/Fluor Enterprises, a JV**OSM Departure Time:** 1830**Contractor:** Oregon Iron Works Clackamas, Or.**Location:** Clackamas, OR**CWI Name:** M. Gregson, J. Salazar**CWI Present:** Yes No**Inspected CWI report:** Yes No N/A**Rod Oven in Use:** Yes No N/A**Electrode to specification:** Yes No N/A**Weld Procedures Followed:** Yes No N/A**Qualified Welders:** Yes No N/A**Verified Joint Fit-up:** Yes No N/A**Approved Drawings:** Yes No N/A**Approved WPS:** Yes No N/A**Delayed / Cancelled:** Yes No N/A**Bridge No:** 34-0006**Component:** Hinge K Pipe Beams**Summary of Items Observed:**

**Hinge-K Pipe Beam Assembly 102A-2:**

**Hinge-K Pipe Beam Assembly 101A-1:**

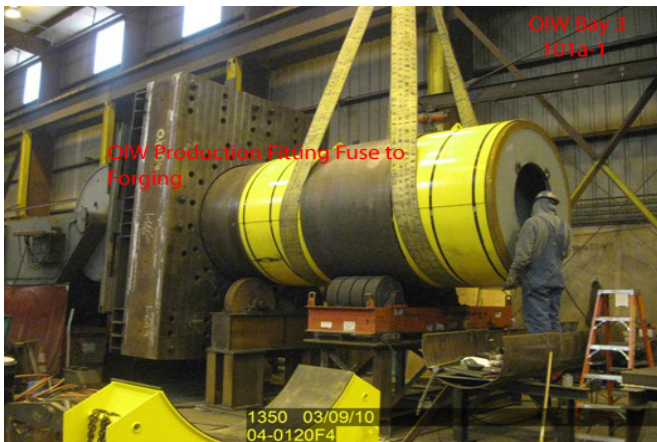
The QA Inspector witnessed WID #B62 (Marcus Belgrade) utilizing a mechanical grinder, to perform grinding on the previously deposited Flux Core Arc Welding (FCAW) tack welds. The QA Inspector noted that these Partial Penetration (PJP) weld joints were designated as #W2-23 (piece mark ab106/a110) and #W2-24 (piece mark ab106/a109). The QA Inspector was later informed by QC Inspector Jose Salazar that the grinding on the tacks had been completed. QC Inspector Salazar explained that he then performed 100 % Visual and Informal Magnetic Particle Testing (MT) on the tack welds and found no rejectable indications. QA Inspector Salazar explained that WID #B62 will be setting up to perform the Submerged Arc welding (SAW) on these weld joint. QC Inspector Salazar explained that he will verify the pre-heat temperatures, prior to SAW and welding parameters during the SAW. See attached pictures below.
